# Evaluation Report 310

## International Harvester 596 Tandem Disk Harrow

# INTERNATIONAL HARVESTER 596 TANDEM DISK HARROW

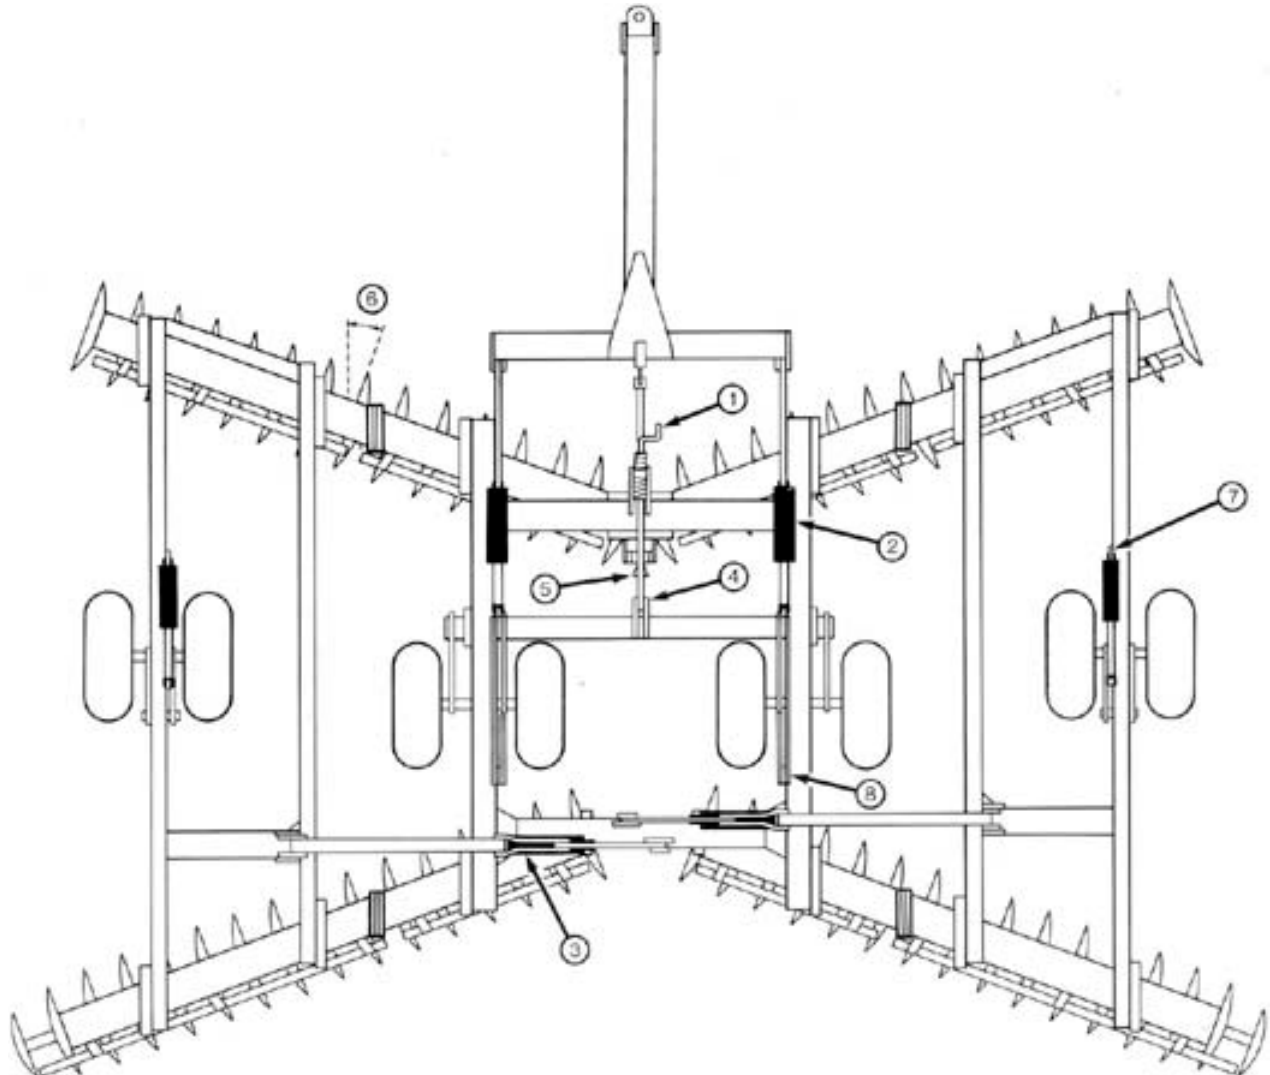
FIGURE 1. International Harvester 596 Tandem Disk Harrow (1) Levelling Crank, (2) Depth Control Cylinders, (3) Wing Lift Cylinders, (4) Frame Level Adjustment, (5) Center Shank, (6) Disk Angle, (7) Wing Depth Adjustment, (8) Transport Bars.

Detailed specifications are given in APPENDIX I while FIGURE 1 shows the location of the major components.

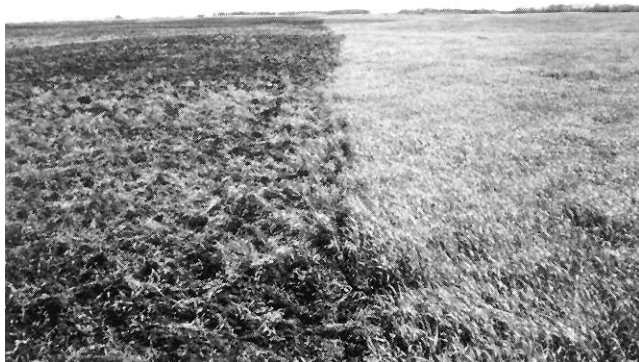
**Trash Burial:** In most fields, 60 to 80% of the trash was buried during one operation (FIGURE 2). If dry, these fields would be susceptible to wind erosion.

FIGURE 2. Typical Trash Burial.

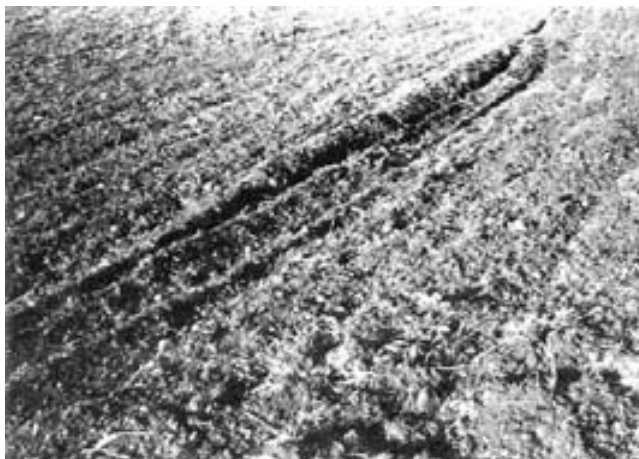
**Field Surface:** The International 596 left a uniform level surface in most fields. The optional furrow filling disks were effective. Hitch adjustments were adequate to prevent ridging or furrowing at the center. Some ridging occurred at the outside front disks when the disk harrow skewed in sharply undulating fields (FIGURE 3).

**Skewing and Stability:** The stability of the International 596 was good except in sharply undulating fields. Skewing occurred when a front corner of the disk harrow penetrated too deeply as it encountered a rise in the field surface. Skewing caused the outer front disk to form a ridge (FIGURE 3). Stability could be improved by using the levelling adjustment to increase the depth of the rear gangs. However, if the rear gang depth was too great, a ridge was formed at the center.

FIGURE 3. Ridge Formed when Disk Harrow Skewed in Sharply Undulating Fields.

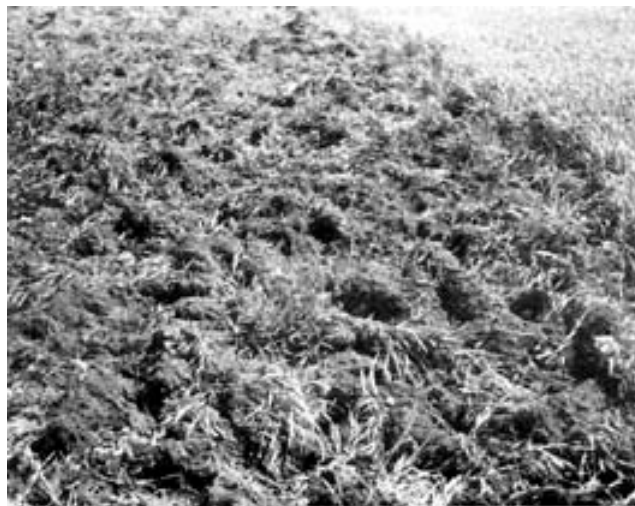
In established sod, the sod strips left a rough field surface (FIGURE 4). A second operation was required to cut up these strips to obtain a smooth field surface.

FIGURE 4. Rough Field Surface in Sod.

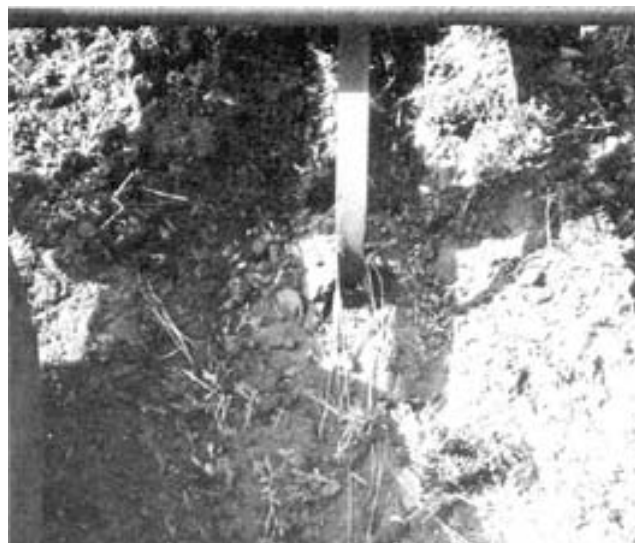
The center shank cleared trash effectively.

The center shank (FIGURE 5) effectively cut the ridge remaining between the two front gangs. The shank was protected by a cushion spring assembly which provided a rock clearance of 7-1/4 in (183 mm) before the shank contacted the wheel axle (FIGURE 6).

FIGURE 5. Center Shank.

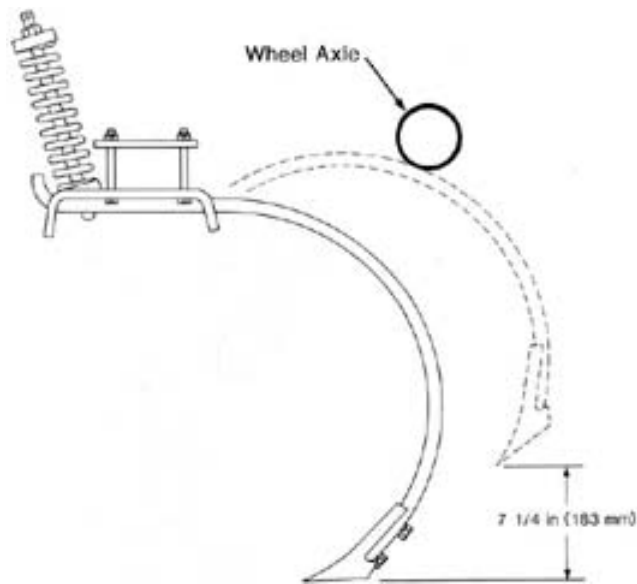
FIGURE 8. Center Shank Tilting Pattern.

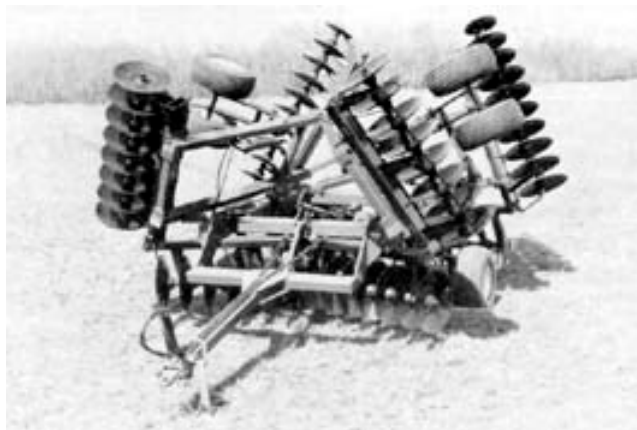
**Transporting:** Ease of placing the International 596 into transport position (FIGURE 7) was good. It usually took less than two minutes. The operator had to crawl under or over the machine frame to move the pins in the transport bars. The wing lock pins were conveniently installed from the rear of the disk harrow.

Transport height was 11.4 ft (3.5 m) while transport width was 15.3 ft (4.7 m). Care was required when transporting on public roads, through gates and over bridges.

FIGURE 7. Transport Position.

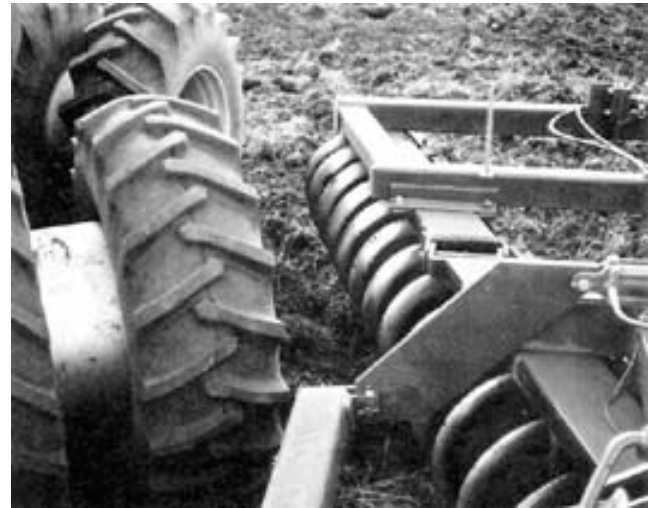
**Maneuverability:** On sharp turns, the tire lugs on tractors with dual wheels, caught on sharp corners of the hitch members (FIGURE 8) and were damaged. It is recommended that the disk harrow be modified to prevent tractor tire damage when making sharp turns.

FIGURE 8. Tractor Tire Contact with Frame.

2. The hydraulic hoses supplied extend approximately 30 in (760 mm) past the hitch pin which we feel is adequate for most tractors.
3. We feel the present hitch design is adequate as it permits 90° turns if the outside of the tractor tires are less than 151 in (3.85 m) apart and the drawbar pin is at the recommended ASAE location.

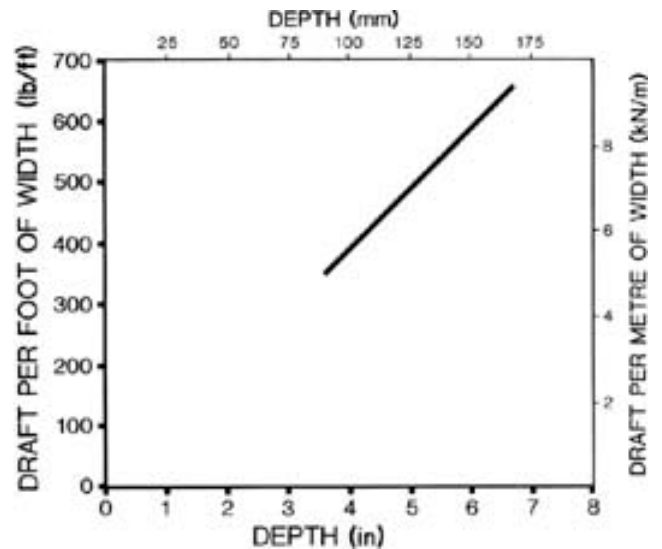
**Draft Characteristics:** FIGURE 9 shows average draft requirements for tandem disk harrows in primary tillage at a speed of 5 mph (8 km/h) at a 20° disk angle.

This figure gives average requirements based on tests of two makes of tandem disk harrows in one season and several different field conditions. Attempting to compare draft requirements of different makes of tillage machines is usually unrealistic. Draft requirements for the same machine in the same field may vary by as much as 30% in two different years due to changes in soil conditions. Variation in soil conditions may affect draft more than variation in machine make, usually making it impossible to measure any significant draft differences between different makes.

In primary tillage, average draft at 5 mph (8 km/h) varied from 388 lb/ft (5.7 kN/m) at 4 in (1100 mm) depth to 584 lb/ft (8.5 kN/m) at 6 in (1150 mm) depth. This corresponds to a total draft ranging from 9740 to 14,660 lb (43.9 to 65.5 kN) for the 25.1 ft (7.7 m) test machine.

FIGURE 9. Average Draft Requirements for Disk Harrows at 5 mph (8 km/h) and 20° Disk Angle.

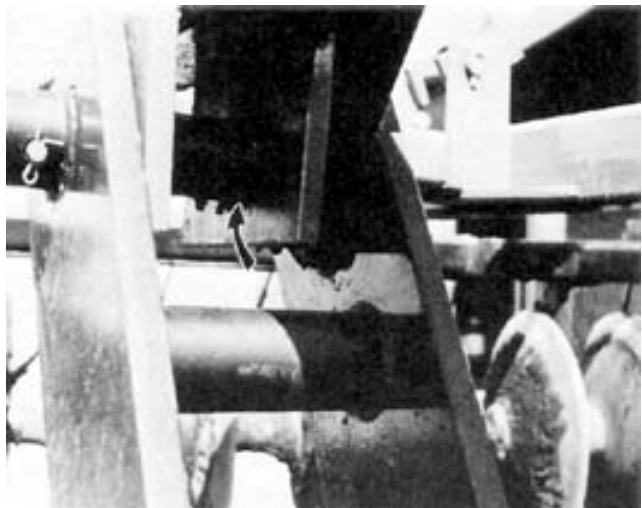
**Weld Quality:** Weld quality was poor in several places on the test machine. This resulted in a weld failure on the right wing wheel support (FIGURE 10). It is recommended that the manufacturer improve weld quality.

**FIGURE 10.** Weld Failure on Wing Wheel Support.

8. No other similar failures have been experienced, however, manufacturing has been advised of the reported weld failure.
9. We feel the routing is adequate as it was done in cooperation with the hose manufacturer.
